Argumentation BIANCA butterfly valve with ULTRAFLO[®] liner

Extremely low permeability for a longer operating life and improved safety

Argumentation BIANCA butterfly valve with ULTRAFYLON® liner

Excellent abrasion resistance and significantly reduced wear

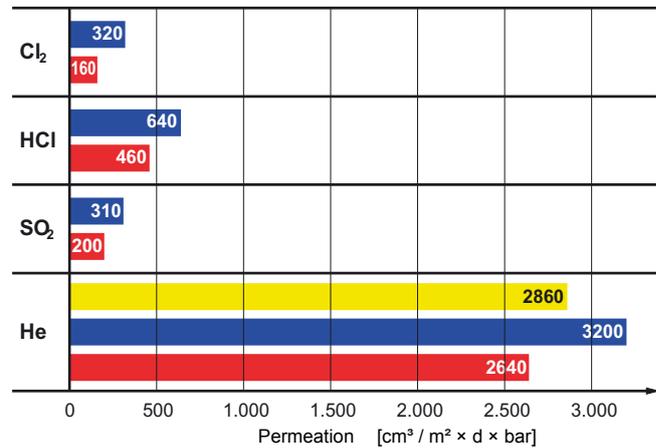
Permeation
Comparison of **ULTRAFLO[®]** - PTFE - PFA
(film thickness 1mm)

Highly concentrated acids and aggressive gases are able to diffuse through conventional PTFE liners and can attack or even destroy the back liners or the inside of the housing after only a short period of use. The rate of diffusion increases with rising temperature. The hardening of the back liner material can cause leaks around the shaft and result in a higher torque on the butterfly valve. Reduced operational safety is the result.

Because of its more dense polymeric microstructure, the new **ULTRAFLO[®]** lining, which can be fitted optionally in the **BIANCA butterfly valve**, is effective in reducing the diffusion of concentrated acids and aggressive gases and guarantees the trouble-free functioning of the valve over a longer operating life. The operator benefits from improved operational safety when handling aggressive and ultrapure media.

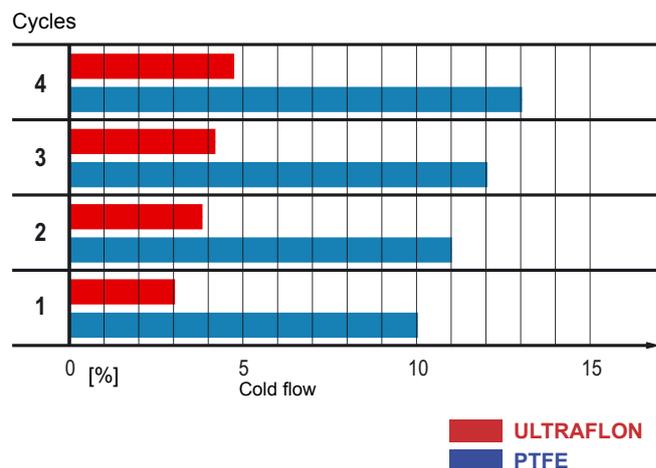
Deformation

under repeated load „Cold flow behavior“

Loading : 15 N/mm², 4 cycles
Duration : 100 hours each cycle
Temperature : 23°C (73°F)
Perm. deformation after 24 hours recovery

When the exterior sealing surfaces of a solid PTFE liner are compressed between the sealing surfaces of the valve flange, there is a tendency for the PTFE to 'flow' in those areas where there is less mechanical loading, a phenomenon known as cold flow. The non-chambered part of the liner in the valve housing (if present) flows radially outwards from the central valve axis. To prevent leaking, the flange must therefore be retightened regularly. However, repeated retightening of the flange can cause the liner to shear. High switching rates also cause additional cold flow on the inner side of the lining towards the backliner. The sealing surface deforms becoming concave and the result are leaks in the pipework at that point allowing the entrained medium to escape.

The much denser polymeric microstructure of the new **ULTRAFLO[®]** liner, which is optionally available with the **BIANCA butterfly valve**, exhibits a significantly lower tendency to undergo cold flow. The problems associated with cold flow are thus effectively prevented, guaranteeing trouble-free valve function over a longer operating life. The improved stability of the **ULTRAFLO[®]** liner makes it the liner of choice for vacuum applications. The operator benefits from improved operational safety when handling aggressive and ultrapure media.

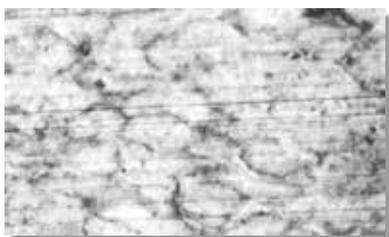
25x enlargement of the surface of a unprepared PTFE liner

Whereas particle boundaries are still clearly visible after sintering PTFE, the **ULTRAFYLON®** liner exhibits a homogeneous surface free of particle boundaries.

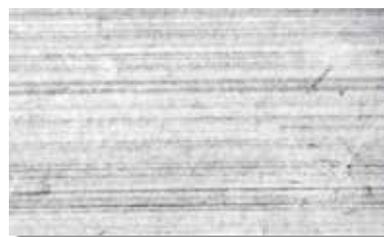
25x enlargement of the surface of a unprepared ULTRAFYLON® liner

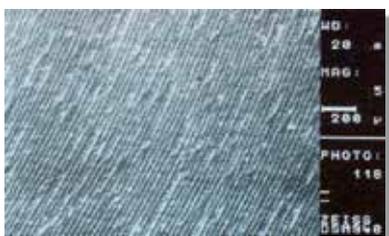
50x enlargement of the surface of a machined PTFE liner

After machining, the surface of the **ULTRAFYLON®** liner is much smoother than that of a liner made of PTFE making the **ULTRAFYLON®** component less susceptible to abrasive wear.

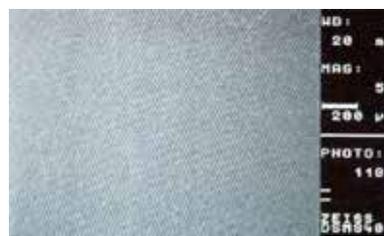
50x enlargement of the surface of a machined ULTRAFYLON® liner

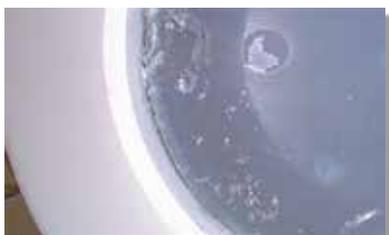
Abrasion of a standard PTFE liner

With its **ULTRAFYLON®** lining collar, precision machined to extremely high tolerances, the **Bianca** butterfly valve has been shown to have the lowest degree of material abrasion between the liner and the disc. Endurance tests have demonstrated that the quantity of abraded particles released into the medium is significantly reduced with **ULTRAFYLON®** liners. The significantly reduced wear means a longer operating life for the valve, thus ensuring increased safety and a corresponding fall in maintenance costs.
